## Summary of DTL tank 3 BPM pickups

by J. O'Hara, M. Plum, and J. Power  
May 21, 2002

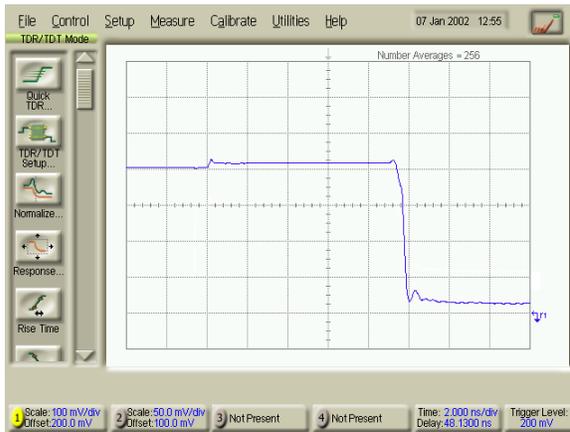
Figure 1. Calibrated TDR trace of 3\_2 right lobe cable prior to welding. The cable is undamaged.

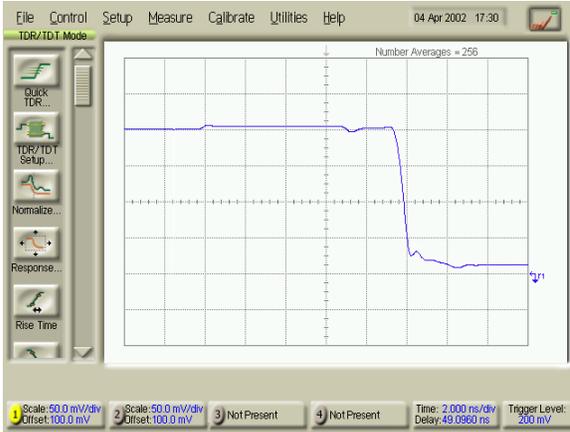
After the BPM is welded into the drift tube, the next step was to weld the water cooling tubes from which the drift tube will eventually be suspended in the DTL. During this process the oval inner tubes were bent on both units. In one case (DT #3-8) a portion of the inner tube had to be cut off about 3 inches above the water diverter and a new one welded on. The stem on the other BPM (DT #3-2) had a leak where the water cooling tubes attach to the drift tube body. Subsequent TDR checks, (see, e.g., Figs. 1-5) showed that the BPM cables inside the stems were damaged, most likely during these repair operations, although there is a slight possibility that the damage occurred during the earlier welding operations for the initial attachments of the water cooling lines. The TDR pulses also exhibited rounded off rather than sharp corners, indicating degraded high frequency performance.

Figure 2. Calibrated TDR trace of 3\_2 right lobe cable after welding as delivered to LANL. Damage to the cable can be seen in the region where the stem is welded to the drift tube body.

**Recommendation:** *Fabricate new drift tubes and new BPM pickups. Install after DTL tank 3 is delivered to ORNL but before it sees beam.*

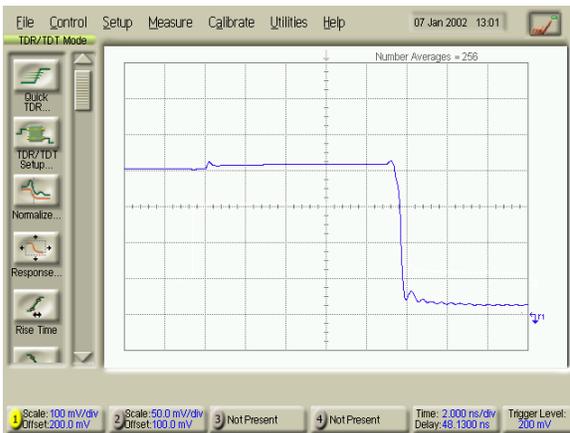
Figure 3. Calibrated TDR trace of 3\_8 bottom lobe cable prior to welding. The cable is undamaged.

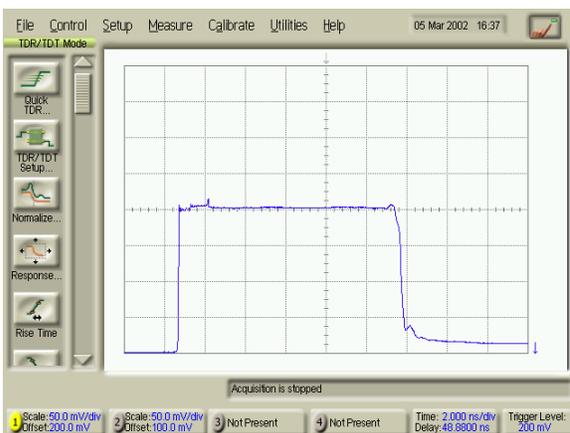
Figure 4. Un-calibrated TDR trace of 3\_2 bottom lobe cable after welding and stem repair as observed at Continental Machine Shop. The cable connectors had been removed in the repair so the TDR could not be properly calibrated. The cable appears to be undamaged at this point.

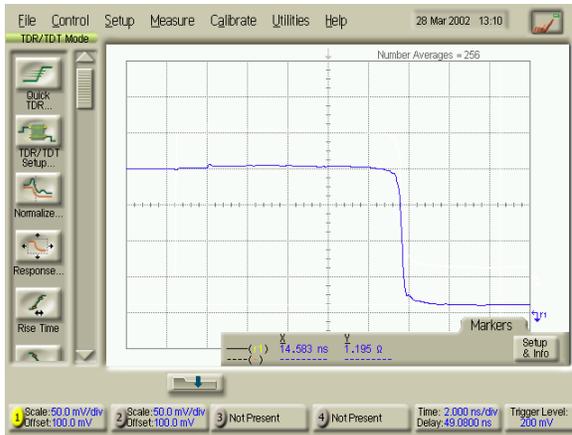
Figure 5. Calibrated TDR trace of 3\_8 bottom lobe cable as delivered to LANL. Unusual high-frequency losses near the lobe-end of the cable are unexplained, but indicate undesirable changes in the cable transmission characteristics at 805 MHz (as observed in the S11 network analyzer data).
